Ecological Assessment of RUBB Building at Wylfa Power Station

Report and Survey by Sarah Cartmel

Survey December 2023

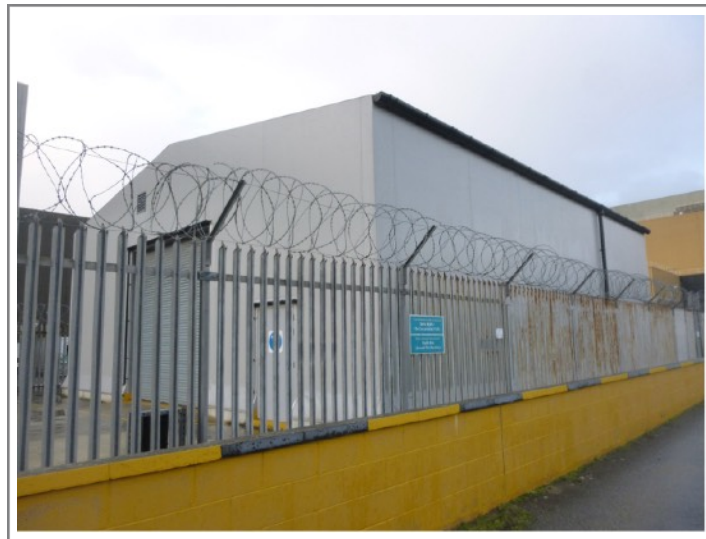
- a) The building consists of a large metal frame built over a concrete floor, with a large thick plastic tarpaulin stretched over the framework (see cover photo). It is approximately 15 x 13 m floor and 7 m tall. It is located outside the main security fence area of Wylfa power station, on the north east side, close to Wylfa Head. There is heathland habitat with gorse *Ulex europaeus* bushes close by on the north and east of the building, immediately west

- b) The exterior of the building is very uniform, there are no fascia boards and no gaps where wildlife could gain entry. The roof material is the same as the rest of the building and there is no evidence that gulls nest on this roof. It is quite possible the material does not provide a suitable surface to nest on.

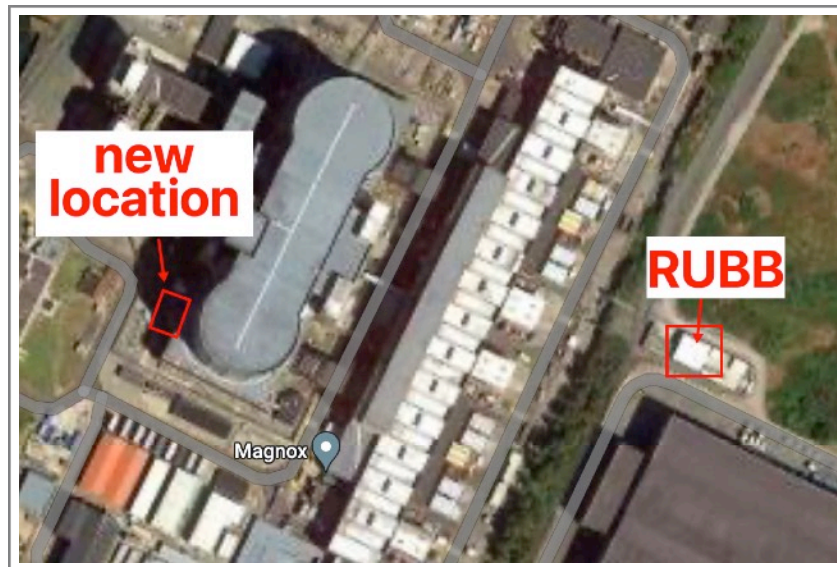
Figure 1. Location of RUBB and proposed new location

is a thin line of conifers and then the main area of Wylfa Power Station and to the south is large metal building (Figure 1).

- f) The proposed new site for the building is on the west side of the main turbine building (Figure 1 and 2). This area consists of hardstanding with no vegetation. The construction of the new building in this vicinity will not impact any protected species or other wildlife. The new building is relatively close to another building where herring gulls nest. The

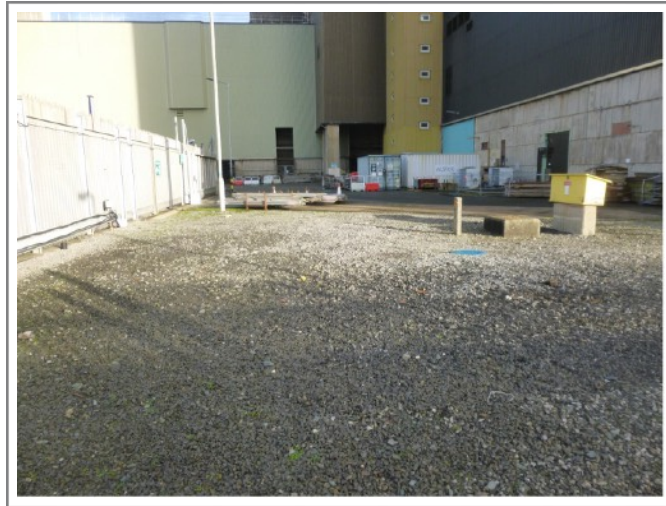
Figure 2. Proposed new location of RUBB building

construction work is not likely to disturb the nests but there is the potential for construction workers to be affected by aggressive gulls if the work commences during the nesting season (May to July).

- d) It is recommended to start construction of the new building outside the gull nesting season or until such time as the gulls have finished nesting or are no longer being aggressive - there is concern of gulls attacking the construction workers. There is no suggestion that the work will directly impact the nests as the building work is far enough away to not directly disturb any nests.
